Flash Report on The Niigata-ken Chuetsu-oki Earthquake

Summary of the Niigata-ken Chuetsu-oki Earthquake

On July 16, ABS Consulting sent two structural engineers (Mr. T. Ogawa and Ms. M. Ozawa) to the affected areas in Kashiwazaki-city and Kariwa-village for three days to investigate the damage caused by the earthquake. The areas marked 'X' in the Figure 1 show the locations investigated.

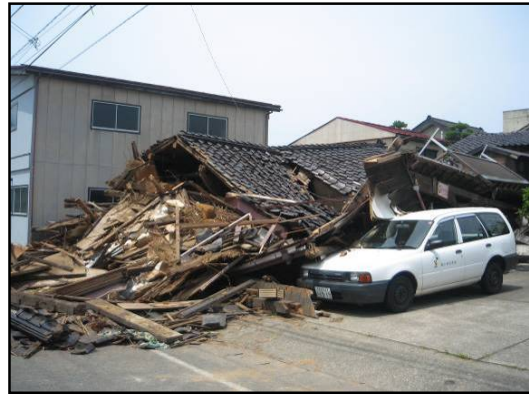
Photo 1

The collapsed houses were mostly old wooden buildings. The traditional heavy black roofing tiles, which are typical in the Northeastern coastal areas of the Sea of Japan, were used on the traditional and old wooden houses. Many of the roofs retained their shape even if the other parts of the houses collapsed completely (Photo 1). The roofs are traditionally constructed using a thin layer of clay to keep the tiles in place. However, the purpose of the is more for insulation purposes since Niigata has cold winters.

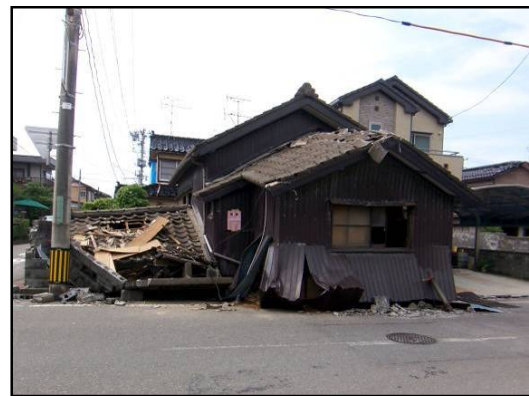
Photo 2

There were many examples that showed that the first story of houses collapsed when that level had many window and door openings while the second story of the same houses maintained its shape and integrity (Photo 2). After the 2007 Noto Hanto Earthquake, similar damage patterns were observed in wooden houses.

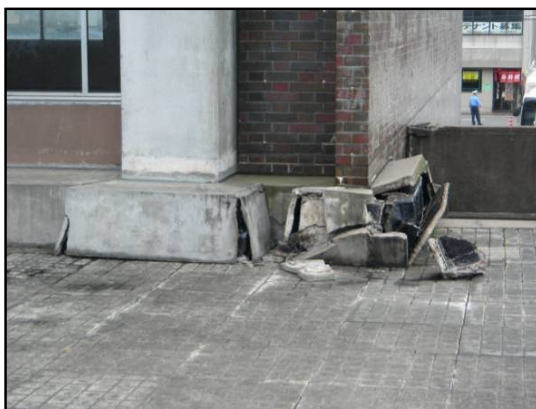
Photo 3

Reinforced concrete buildings in the urban areas were also damaged. At the Kashiwazaki-city office building some of the columns were damaged (Photo 3). On the second-story parking level of a big supermarket, a water tank suffered damage (Photo 4).

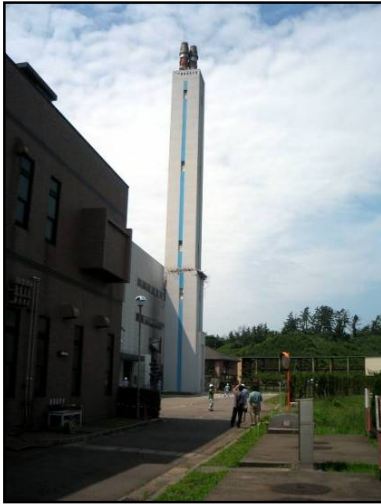
Photo 5

Furthermore, at the Kashiwazaki-city's rubbish incinerating facility a 59 meter high by 4.6 meter wide reinforced concrete exhaust chimney was broken at approximately 10 meters, which is slightly below the center of the chimney (Photo 5). Based on the condition of the protruded reinforcing, the chimney broke at the lapped reinforcing joint (Photo 6).

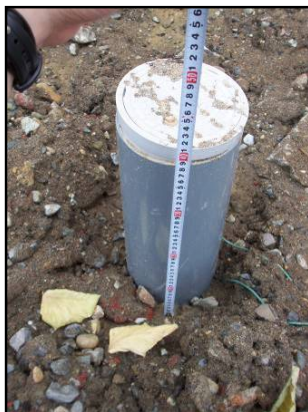
Photo 7

The General Affairs Office in Nishiyamacho Kashiwazaki-city is located in the middle of this mountainous area. It appeared to have received relatively little damage during the earthquake. However, the pipes in the surrounding area were found to protrude about 400 millimeters above the ground level, which was probably caused by the change in ground level due to the earthquake ground motion (Photo 7).

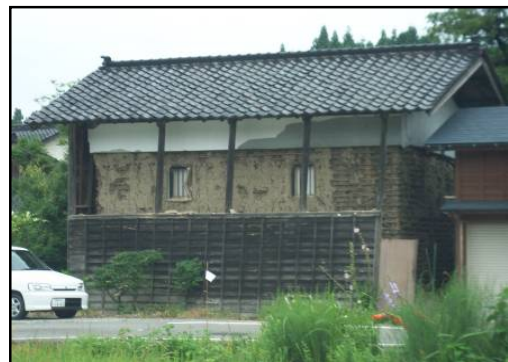
Photo 8

In the same area, many warehouses are constructed with walls made of mud and it was found that many of these walls had peeled off (Photo 8).

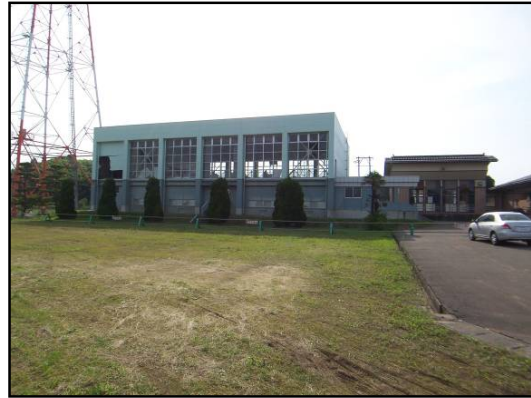
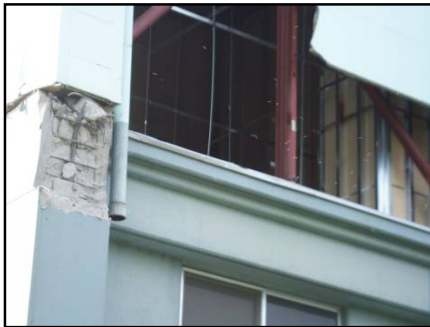
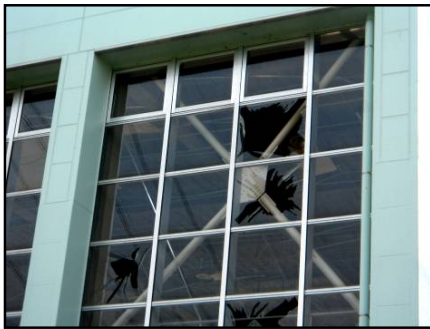
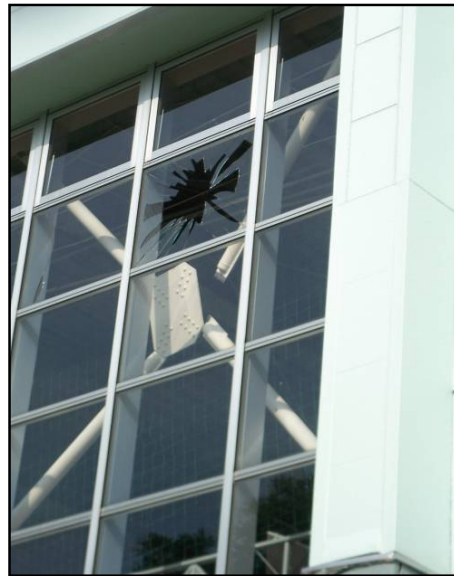
Katsuyama Meeting Hall (Photo 9) is a reinforced concrete building, which suffered damage at the column-girder joints (Photo 10), broken windows, fallen ceiling panels (Photo 11), fallen external cladding and broken steel braces (Photo 12). Although the meeting hall had not collapsed, it will take a long time to restore it to its former state. The lateral forces induced by the earthquake were probably much greater than the design forces. No braces were seen in the ceiling system during our inspection. In the aftermath of recent major earthquakes, the inadequate strength of ceiling systems in large spaces has been noted.

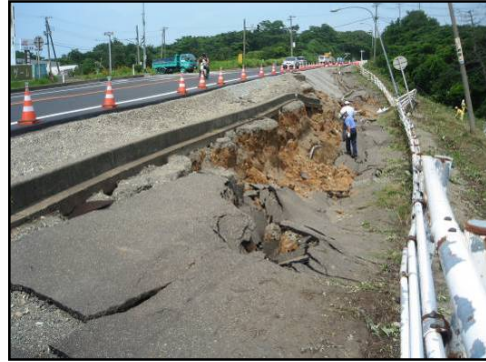
Photo 13

The National Highway Route 8, 116 and 352 passing through Kashiwazaki-city and Kariwa-village had many cracks, uneven surfaces and ground subsidence. Route 8 passing through Kujiranami Kashiwazaki-city was especially badly damaged with a 100-meter stretch of its embankments slipping more than two meters (Photo 13).

Due to rapid repairs, the national highways were open to traffic quickly and were soon fully functional.

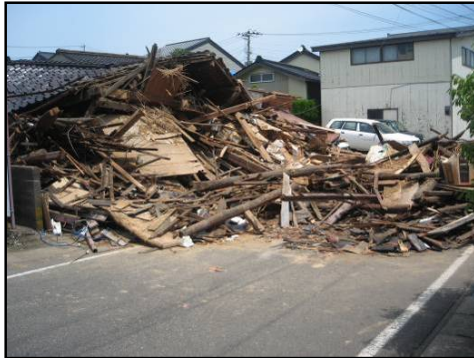
Photo 14

The roads across the city were found to be damaged and had cracks and uneven surfaces in many places. It was also observed that many of the collapsed wooden houses along these roads had blocked the road access (Photo 14). Many of the overpasses over rivers had subsided near the bridge abutments, which impeded traffic (Photo 15).

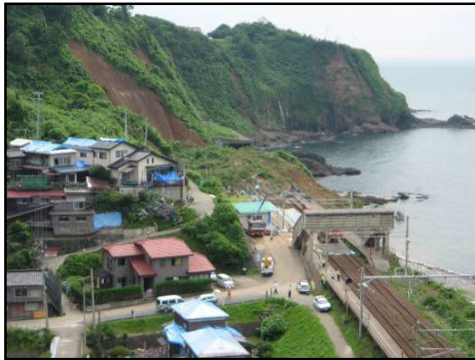
Photo 16

The JR Shinetsu Mainline's Oumigawa station experienced the largest earthquake induced landslide (Photo 16). The heavy rains during the previous day by Typhoon 04W (Man-Yi) may have contributed to this landslide. The landslide caused a large amount of soil and stones from the steep hill behind the railway station to be washed into the nearby coastline. Part of the railway lines and the station's platform were completely buried under the debris. Fortunately, no one was injured by the landslide. Since there are many steep hills around the JR Shinetsu Mainline's Oumigawa station, there were many similar large landslides (Photo 17).

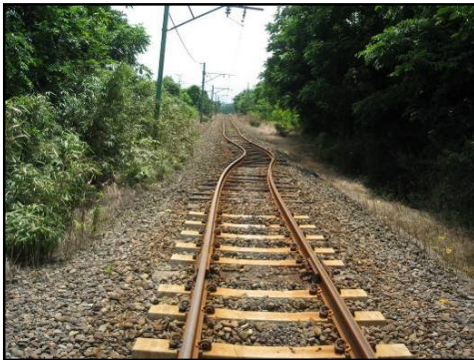
Photo 18

Between Arahama Street and Nishiyama Street on the JR Echigo Line, the rails were found to have been deformed in several places due to soil deformation. The most severely bent rails were bent approximately 800 millimeters (Photo 18).

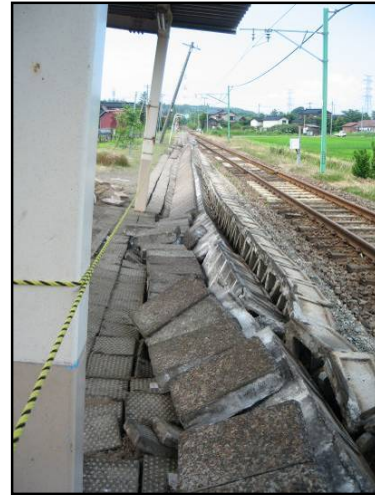
Photo 19

The Arahama station's platform was also completely damaged (Photo 19).

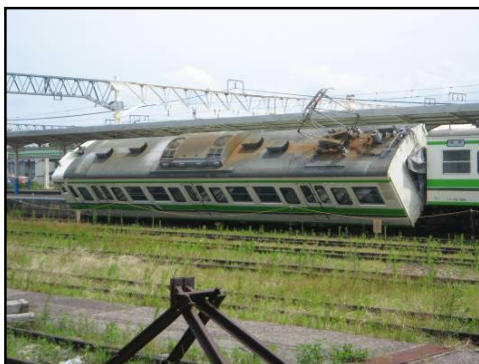
Photo 20

One train car of a two car train on the Echigo's line had stopped at the JR Kashiwazaki Street platform and was derailed by the earthquake (Photo 20). At the time of the earthquake, the train car had one railway worker and two passengers on board, but fortunately, no one was injured.

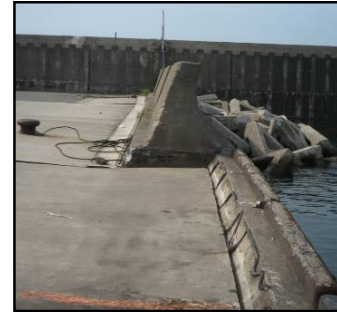
Photo 21

At the west wharf, settlement of the embankments opened joints in the aprons and deformed the ground in the yard area behind the banks (Photo 21). The embankment not only settled 200 millimeters but also moved 500 millimeters from the bank's edge towards the sea.

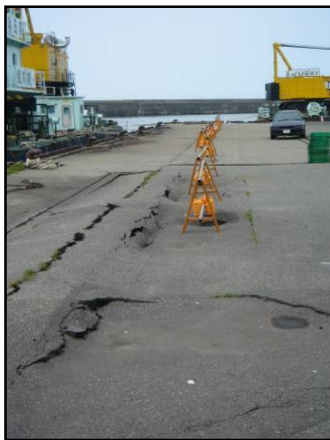
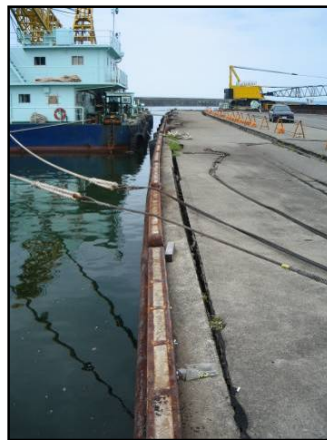
The central wharf area had cracked asphalt, deformed quay walls and uneven surfaces (Photos 22 and 23). Also, in many places around the harbor, remains of blown-out sand caused by liquefaction were observed (Photo 24).

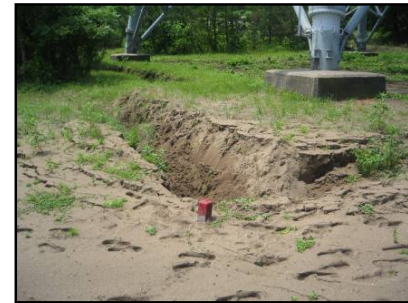
Photo 25

The earthquake caused many locations of boiling sand in Kashiwazaki-city and Kariwa-village due to liquefaction (Photo 25). Manholes and sewer pipes protruded out of the ground (Photos 26 and 27). According to the National Geography and Crustal Dynamics Research Center, the Kashiwazaki urban area is located between the Yoneyama mountain district and the Nishiyama hill region. The area contains alluvial soils where the sand deposits have flowed from the rivers over the soft alluvial formation. These soil profiles were the prime reasons for causing liquefaction to happen in many locations during the earthquake.

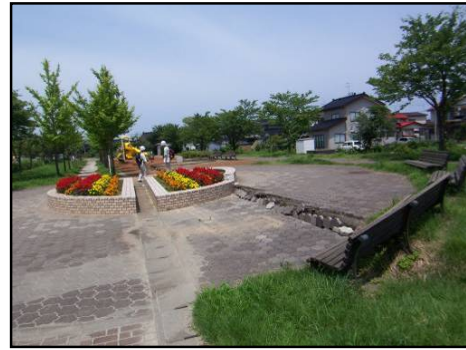
Photo 28

Considerable liquefaction was observed at the Suidobashi Park in Nishimotocho Kashiwazaki-city (Photo 28). This area had been transformed into a park during the flood mitigation effort in 1984 when the Ugawa river system was straightened.
