REPORT

Magnitude 8.0

Pisco Peru Earthquake

August 15, 2007

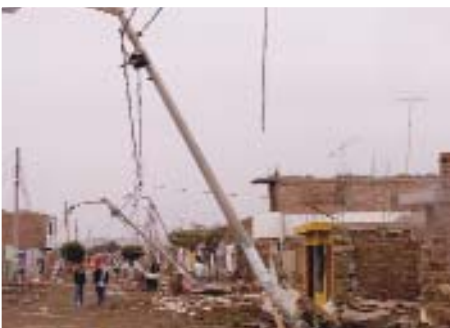
Tambo de Mora street with extensive liquefaction.

Extreme liquefaction was observed in Tambo de Mora, on the coast west of Chincha Baja, in Paracas, and at Port San Martin. In Tambo de Mora, adobe, brick and concrete block houses settled into the liquefied soil as much as four feet.

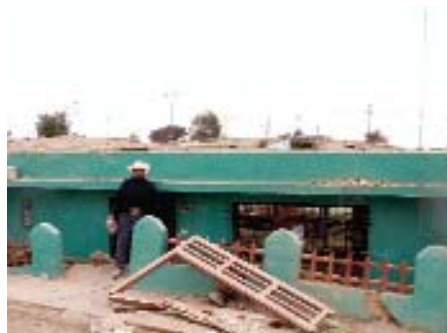
Tambo de Mora house settled four feet.

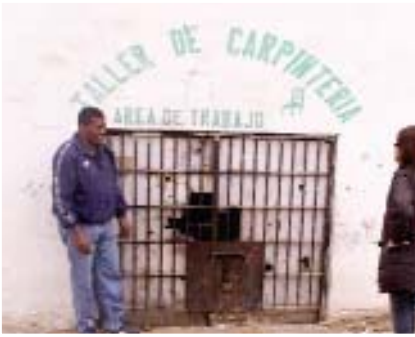
Chincha prison door/wall settled four feet.

At a regional prison near Tambo de Mora, walls toppled and/or sank into the ground as much as four feet. Power poles and light poles toppled. Approximately one km east of the prison, a scarp formed along the eastern edge of a large block of soil hundreds of meters in each dimension indicating lateral movement.

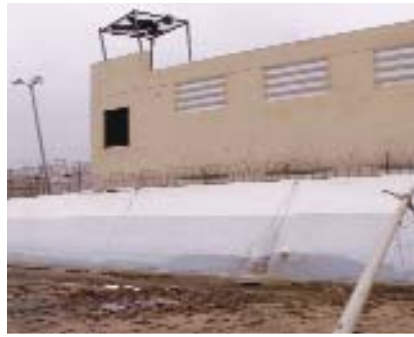
Chincha prison wall and power poles tipped.

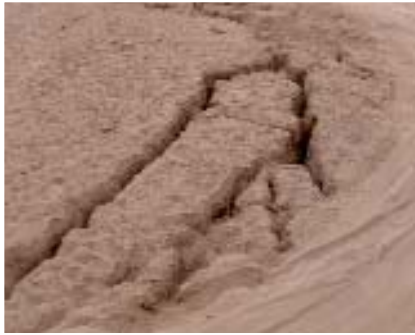
East edge of lateral spread Tambo de Mora.

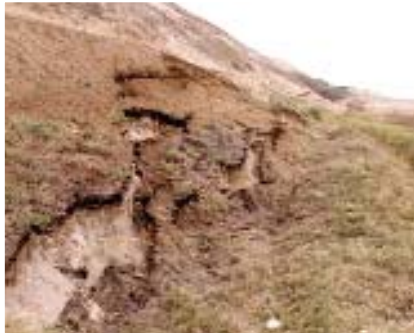
Scarp on east edge of lateral spread.

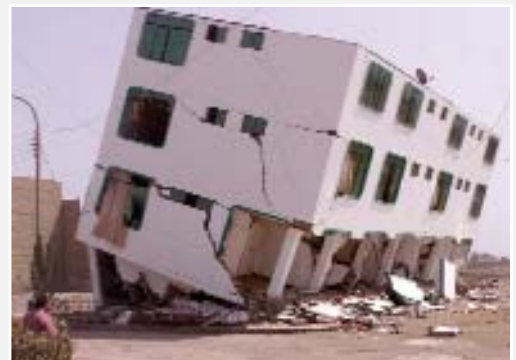
A high percentage of housing was constructed of adobe, which performed poorly. Most of the fatalities resulted from the collapse of adobe structures. Most multistory structures, as high as five stories, consisted of a reinforced concrete frame with infill comprised of hollow tile or brick. The damage mechanism for these types of structures was that the infill falls out when subjected to out-of-plane loading. Once the infill masonry is gone, the concrete frame has little lateral load resisting strength, and collapses. Some of these structures performed well while others collapsed. The specific design and detailing influenced their performance. In several cases, soft stories (buildings with limited lateral support on the first floor) collapsed.

Building collapsed due to soft story.

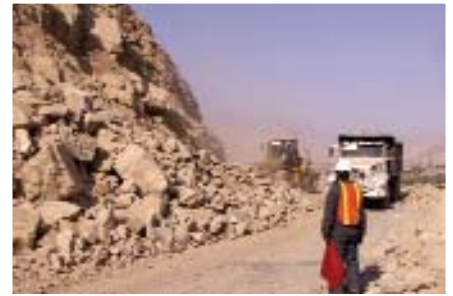
The Pan American Highway from Lima to Pisco and Ica was closed immediately following the earthquake due to a rockslide just north of Chincha. Slides also occurred in roads leading to the Andes.

Rock fall on road east of Indenpencia.

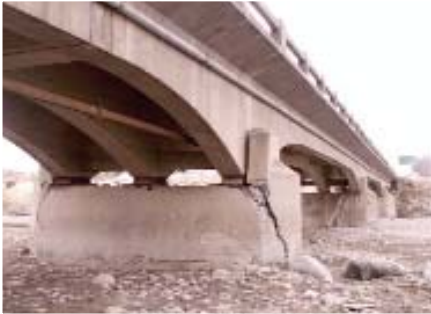
PanAm highway bridge over Rio Pisco.

Six days after the earthquake, the highway was open in one direction, but was closed again several days later. Just downstream of the bridge, a concrete panel lining the river dike/bank had slumped down the bank. Other bridges in the impact area were observed, but only very slight damage was found.

Other sections of the highway suffered from liquefaction/cracking, but probably remained passable immediately following the event. The only damaged bridge that was identified was on the Pan Am Highway crossing the Rio Pisco, just south of San Clemente.

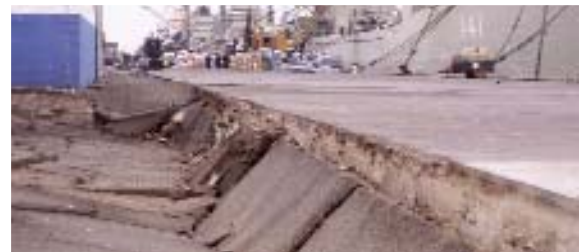
Loading emergency supplies/settlement.

The front (water side) 60 feet is pile supported. Fill behind a sea wall settled about three feet, and pushed the wall towards the piles, slightly bending them. A warehouse just behind the sea wall had pile-supported walls. The floor and surrounding area settled about two feet, with extensive evidence of liquefaction. The port personnel were unloading coal and emergency supplies while the reconnaissance team was in the area.

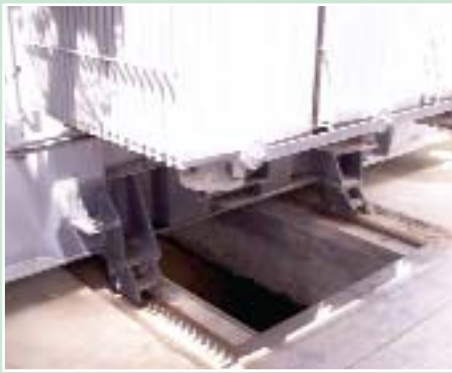
60KV transformer moved on rail breaking insulators.

Electricity is produced by hydro power. High voltage lines (appeared to be 230 KV) transmit the power from the Andes to a substation in Independencia, about 12 miles inland. There was no apparent damage to this substation. Power is then distributed at 60 KV from this substation through multiple circuits serving Pisco, Ica, and Paracas. On the circuit serving Paracas/San Andreas, three line supports failed. Two transformers at this substation (60 KV-10 KV) rolled on the support track, breaking insulators where the wire connections were fixed.

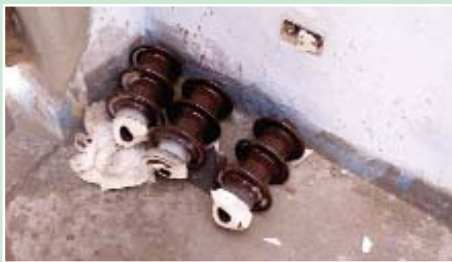
Broken insulators.

The building housing the substation, which is a reinforced concrete frame with infill masonry, had only slight structural damage. The transformer at this substation leaked oil, causing it to fail. Power company personnel indicated that substations were operational within one day. However, there were many damaged poles, in addition to poles that had toppled in liquefiable soil. Service drops were cut when buildings collapsed (particularly in Pisco). Workers indicated that it would take two weeks to restore power completely.

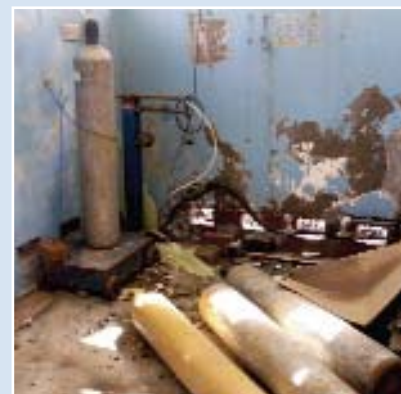
Pisco gets water from a infiltration gallery 18 miles east of town. Pipeline damage along the transmission line into the town reduced the flow from 4700 GPM to 2700 GPM. The chlorine disinfection system at the operations center in Pisco was damaged from ground motion.

Chlorine room under elevated tank.

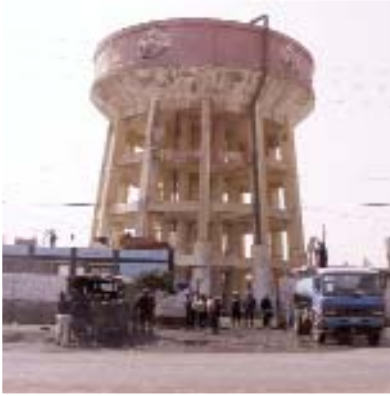
Elevated tank/emergency water distribution.

The Pisco system had one 370,000-gallon concrete elevated tank (where their operations center is located) and one 1.2-million gallon ground-level tank. The elevated tank support structure had spalling at the joints. The ground level tank appeared undamaged. Many concrete elevated tanks throughout the region appeared to be undamaged.
